International Project for the Efficient Use of Energy
International Project for Establishment of Infrastructure
for the Efficient Use of Energy
(Promotion of Energy Efficiency and Conservation
for Buildings in ASEAN Countries)

Report on the Results

March, 2006

The Energy Conservation Center, Japan

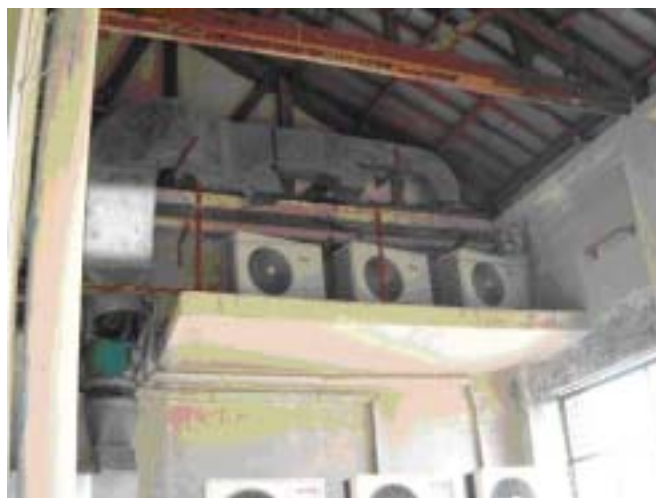
We confirmed this time that a new duct was installed for the outdoor units on the uppermost floor as we proposed. We were told that the improvement was made because the high temperature did not permit the package on the top floor to deliver its expected performance, preventing sufficient cooling in the rooms. The effect of our proposal was confirmed on the top floor, but the improvement work was not applied to the other floors because of the high construction cost.

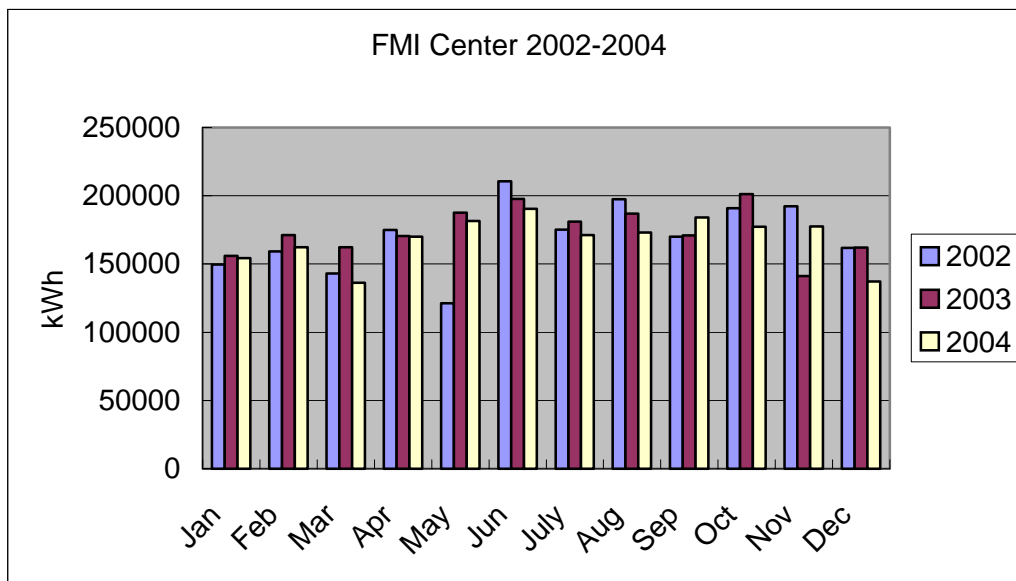
The monthly electric energy from 2002 to 2004 is shown below. There are abnormal values in May and June 2002, which seems to be the problem of data collection. However, we can understand that there is no substantial difference between each month throughout the year.

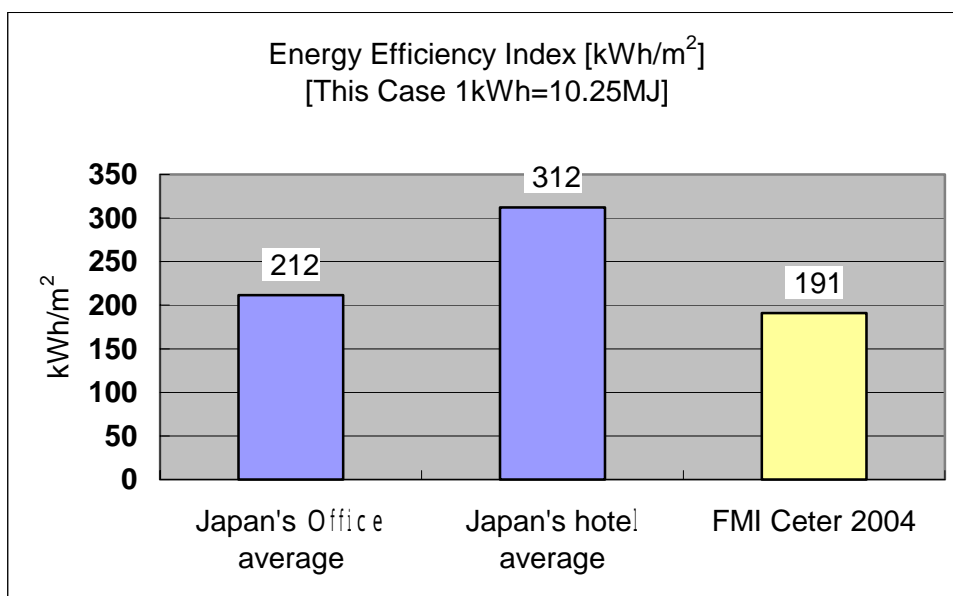
The graph below shows the difference in the energy consumption per unit area in comparison with that in Japanese office buildings and hotels. The electric energy in 2004 is used as the value of FMI Centre, and the values of Japanese cases are converted into kWh by converting the data collected by The Energy Conservation Center, Japan using the ratio of “10.25MJ/kWh.” In comparison with Japanese office buildings, the value is approx. 10% lower than that of Japanese office buildings, which is understandable because the overtime work is less and OA equipment density is low.

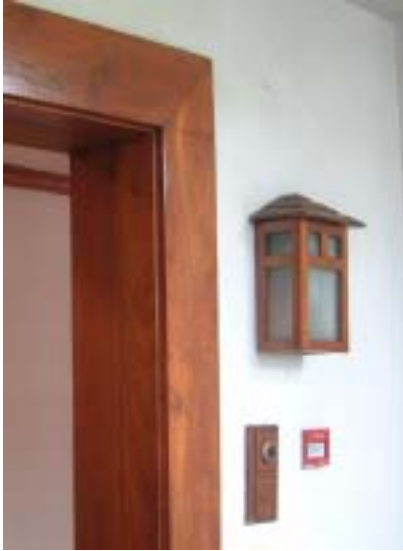
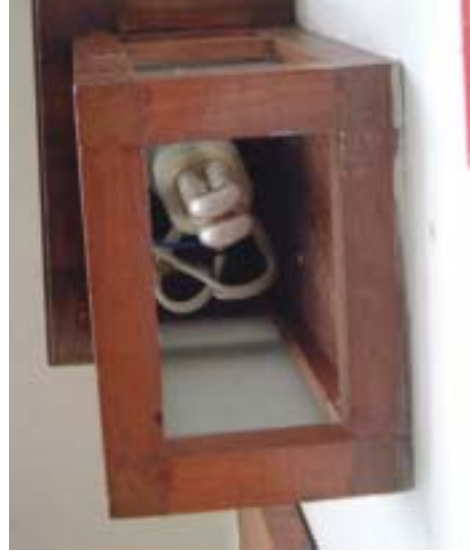
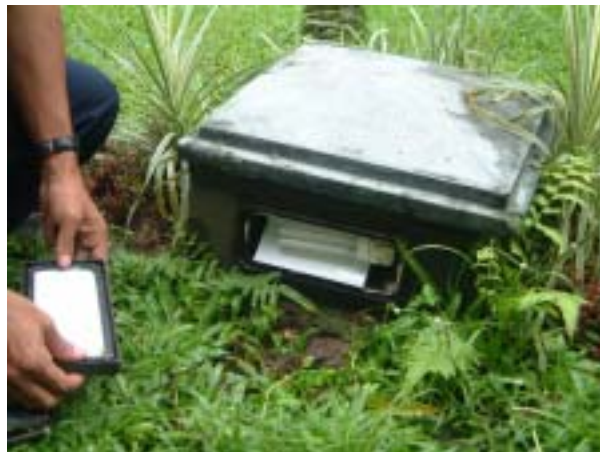
The 40-W lighting fixtures at the entry of guest rooms and in corridors were replaced by compact fluorescent lamps (7 W).

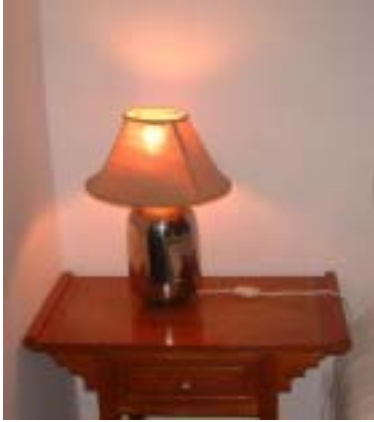
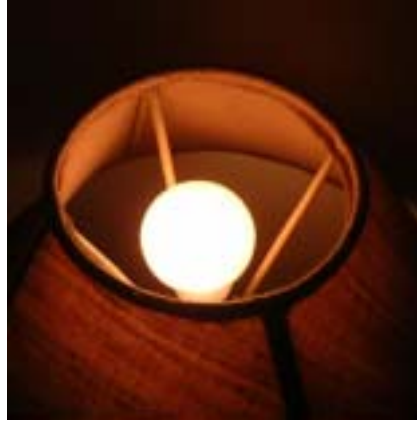
The 40-W lighting fixtures in guest rooms were not changed since aesthetic values were more important in guest rooms.

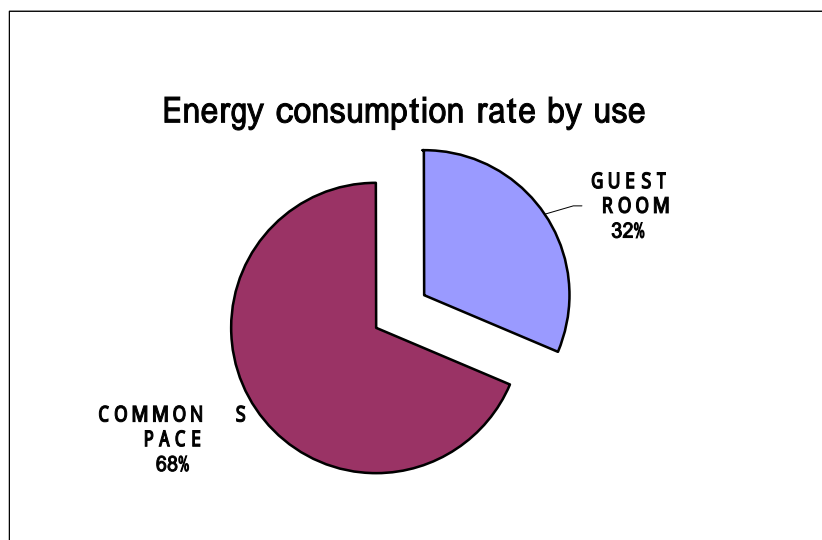
Since the energy consumption rates by use in the hotel are probably not so different from the rates of the last energy audit, the values of the last energy audit are shown here. The percentage of energy consumption in guest rooms is about 32% and the percentage of energy consumption in common areas is about 68%. In guest rooms,

air conditioning takes about 19% (largest) of the entire energy consumption, lighting takes 7%, and water heating takes 4%.

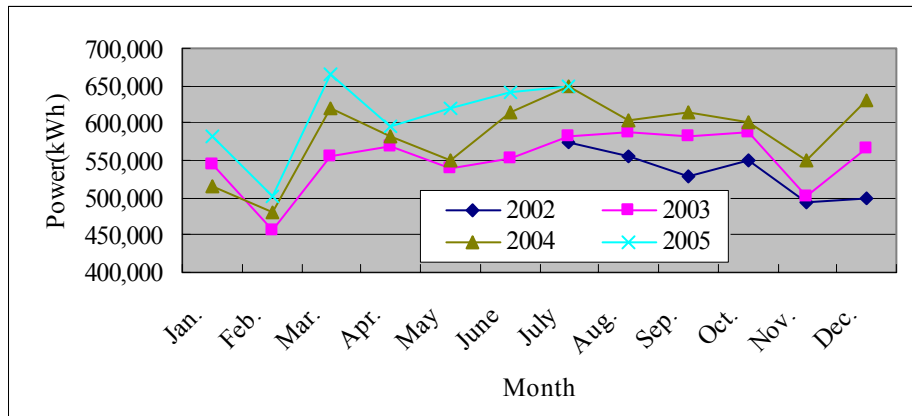
Fig.2.3-1 Monthly power consumption

Similar patterns are repeated every year, and the power consumption minimum in February, while a large quantity of power is consumed from July to October. Since the annual temperature in KUALA LUMPUR is almost constant, other elements (the number of working days and so on) seem to be the cause of the change.

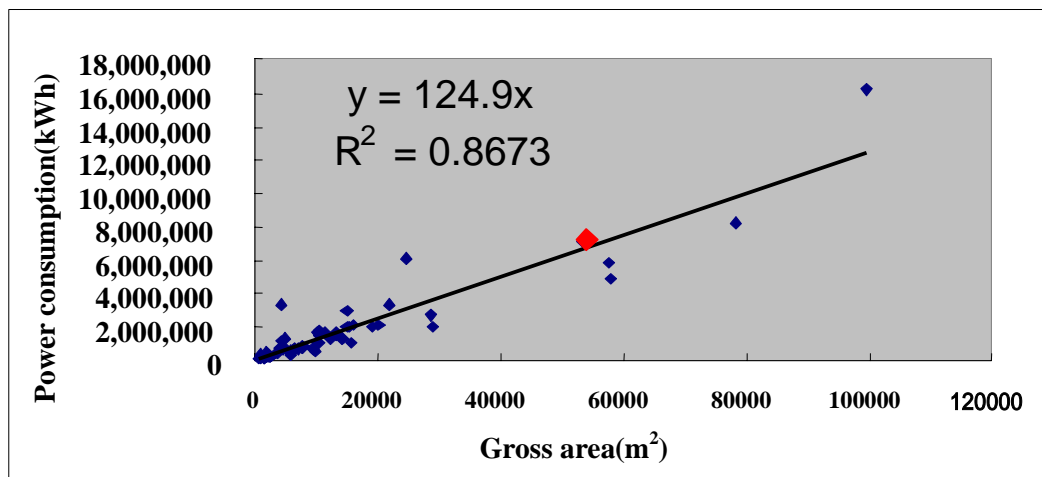
Fig.2.3-4 Power consumption per unit total floor area
(Comparison with data on 59 buildings in Malaysia)

This building is almost on the average line, and the energy consumption of the building is an average. The average value is 124.9 kWh/m², while the value of the Darby building is 127.8 kWh/m², and the ratio is 1.023.

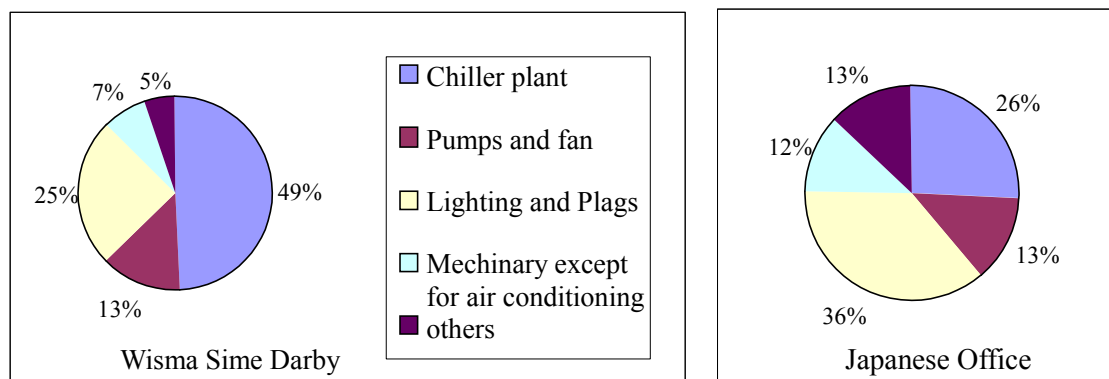
Fig.2.3-6 Power consumption of respective equipments

The energy consumption of respective equipments is calculated based on the mechanical drawings of the Darby building and the operating condition of respective equipments. Empirical values are used for part of estimation, and the values shown below are approximate.

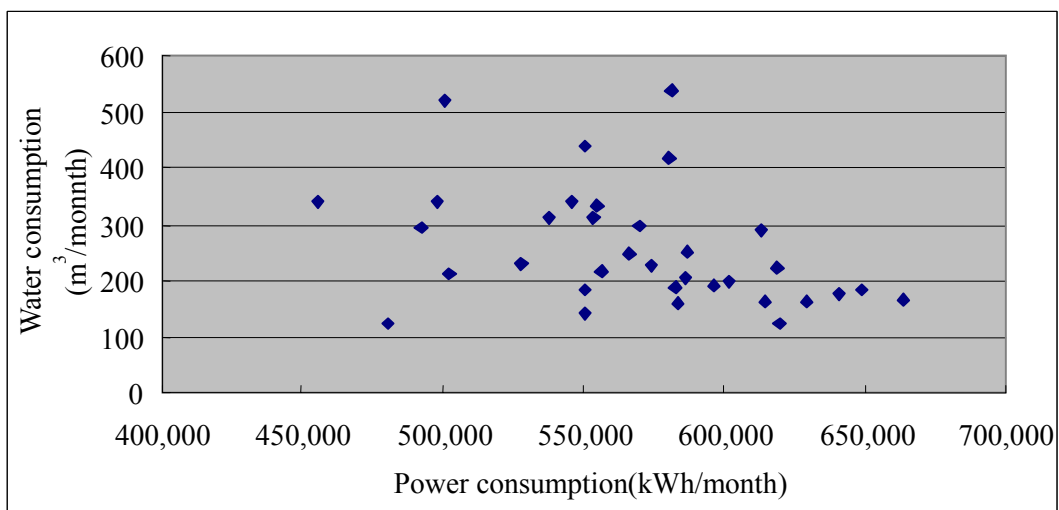
Fig.2.3-8 Correlation between power consumption and water consumption

The water consumption is originally dependent on the tenant occupation rate. The power consumption is also dependent on the tenant occupation rate. Therefore, there must be some correlation between them. The correlation diagram is shown below.

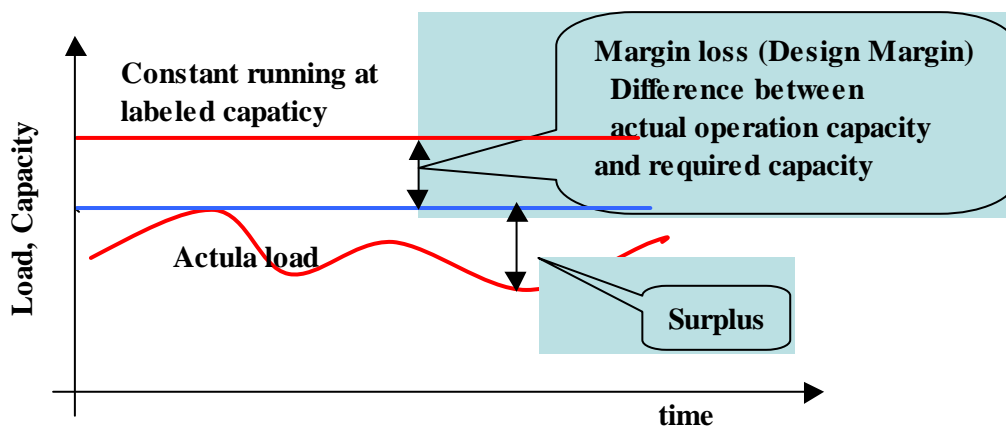
Fig.2.4-1 Structure of waste generation

The air conditioners are constantly operated according to the set rating irrespective of the season, weather or tenant occupation rate, which causes the waste of electricity shown below.

In addition, there is supply surplus caused by load fluctuation. The situation is shown schematically. The initial adjustment of the installed capacity is for minimizing the capacity margin, while the load control of the equipment following the load fluctuation is for minimizing the supply surplus. The latter needs a costly complicated system in general, and the former is comparatively easy.

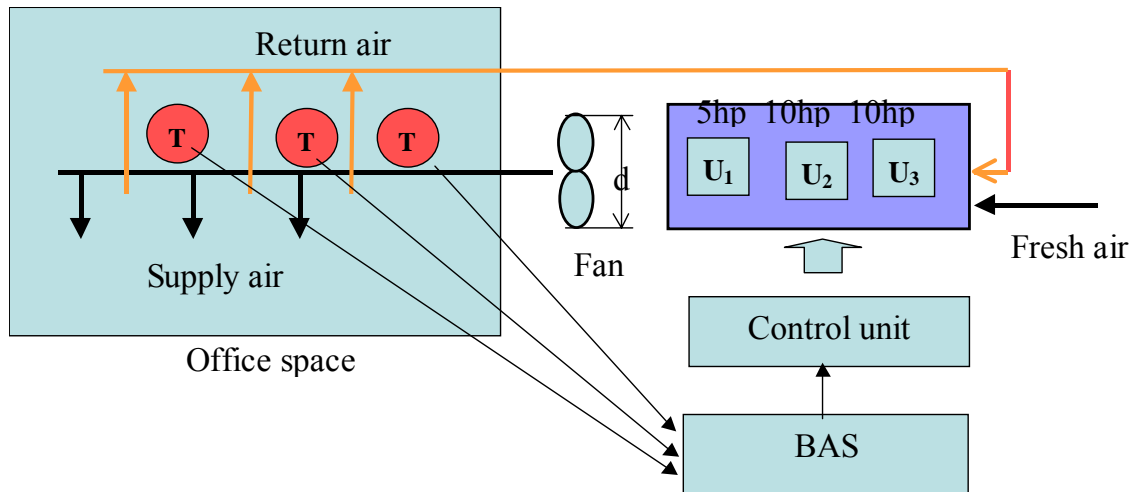
Fig.2.4-2 Control of WCPU capacity

In other words, it is possible to operate by setting the appropriate cooling capacity according to the degree of the load. The figure shown below is the conceptual figure which explains that the proposed operation can be realized by the system which combines the indoor temperature and the control system of BAS.

Estimation condition: The 25 Hp WCPU is operated at the capacity rate of 20 Hp for 2h/d within the low-load time zone. In other words, the 5 Hp unit is stopped.

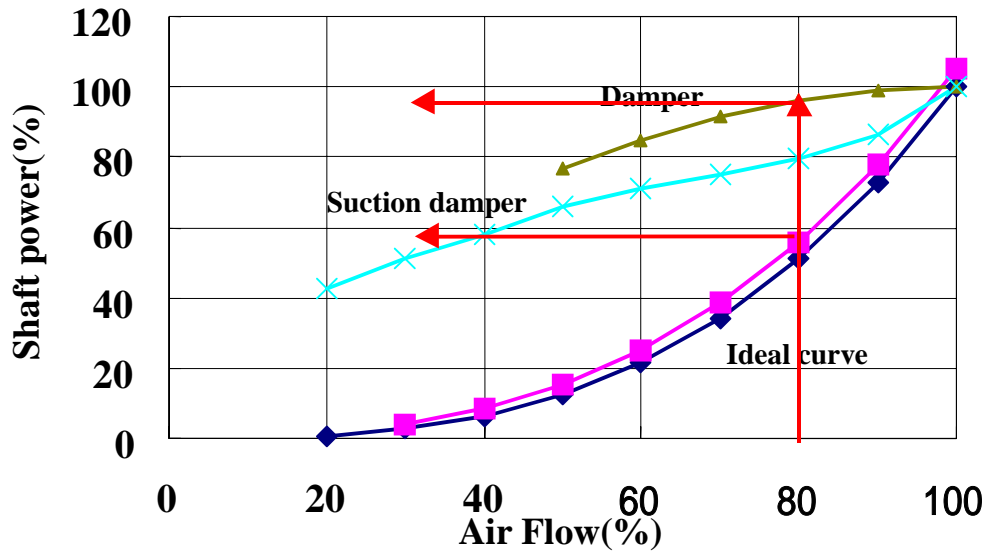
Fig.2.4-3 Comparison of various air volume control methods

The air volume of fans is controlled by the damper. As shown in the figure, the damper control is not efficient. Even if the air volume is reduced to 80%, the shaft power of the motor will be reduced only by 2%.

Estimation condition: The air volume is supposed to be reduced to 80% by damper control in one system (14 units) in the West block, which is to be changed to the control of the number of revolutions by the inverter.

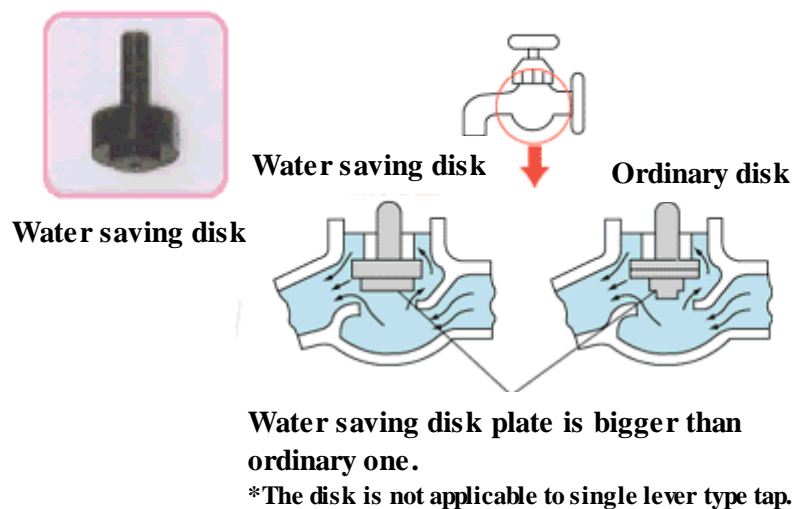
Fig.2.5-1 Structure of water saving disk

The water saving disc is recommended by the Waterworks Department (Japan). When installed in a faucet of a built-in disk type, the water saving disk can save a maximum of approx. 6 liters of water per minutes.

As shown in the figure below, the lower section of the water saving disk is bigger than that of an ordinary disk.

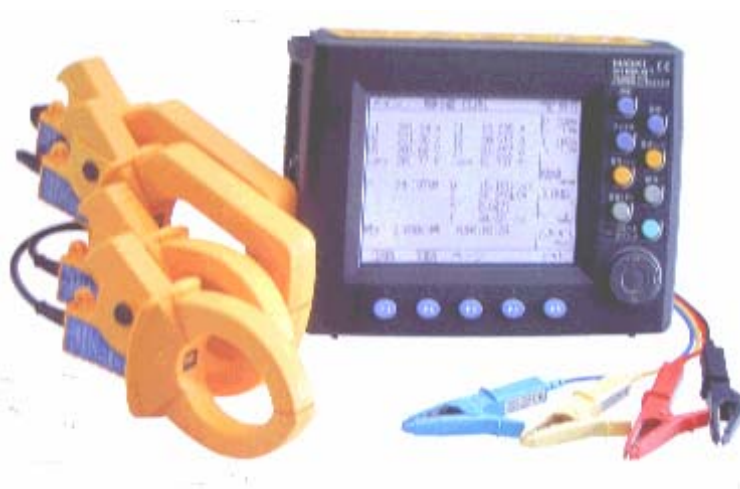
Fig.2.5-3 Watt-hour meter with recording function

Watt-hour meters are necessary for more detailed examination of energy conservation by specifying the equipment. You should study the possibility of introduction of commercial watt-hour meters with a recording function sold by some measuring instrument manufacturers. Recent watt-hour meters are equipped with functions that enable the measurement of higher harmonics, distortion factor and other various electric data, and that also enable analysis by direct input of the data to a personal computer. The photo below shows a watt-hour meter of Company H, priced at approx. ¥400,000 and provided with functions that are used in general. Other measuring instrument manufacturers also provide with the models with similar functions.

You can purchase and use jointly with some cooperative companies. It should be borne in mind that such an instrument is essential for energy conservation activities.

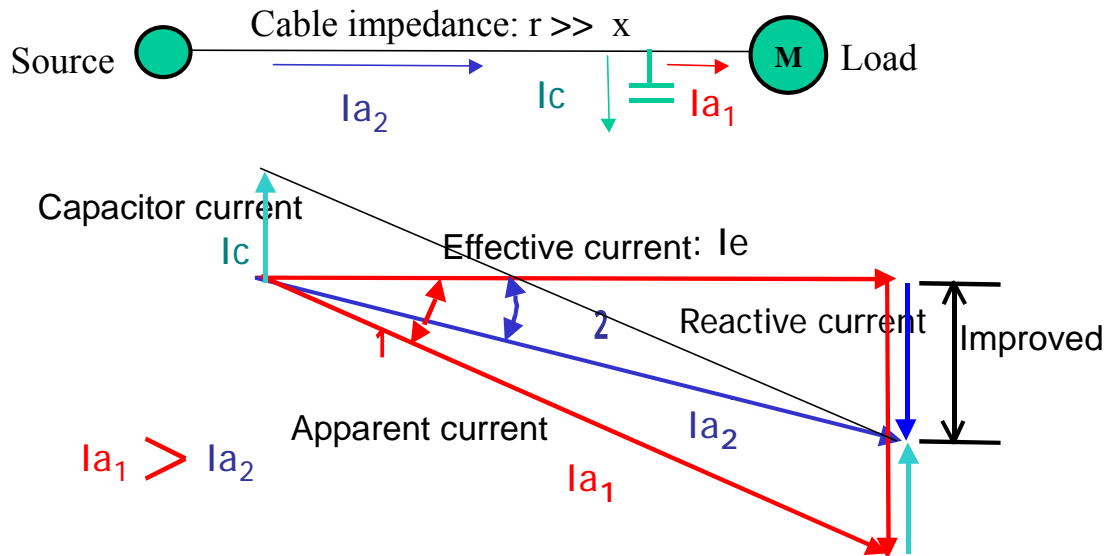
The figure below shows the case where a capacitor for improvement of the power factor of the distribution system. The red lines show the condition before improvement of the power factor, and the blue lines show the condition after improvement of the power factor.

The current (green) of the capacitor for improvement of power factor compensates the reactive power component of the current component of the load. The current in the cable changes from I_{a1} to I_{a2} in this way, reducing the value. From another point of view, the power factor changes from $\cos\Phi_1$ to $\cos\Phi_2$, showing improvement.

It is also recommended to renew the WCPU and examine the possibility of installing a capacitor for power factor improvement. The power factor improvement for loads is to be conducted as an additional work when loads are renewed.

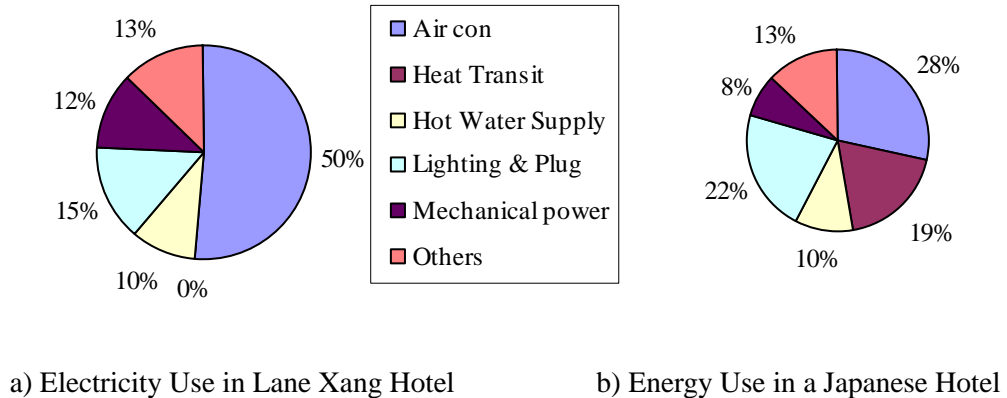
Figure 2.3 - 5 Electric Energy Consumption by Use

We calculate the rate of energy consumed by each use based on drawings and the operation status of facilities. The calculated values should be used only for reference since some of the data is derived from experiences.

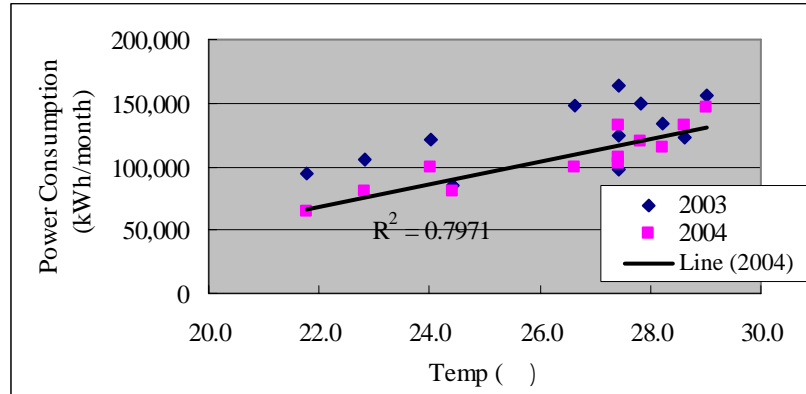
Figure 2.3 - 6 Relationship Between the Electric Energy Consumption and the Outdoor Air Temperature

Fig.2.3-6 shows the relationship between the energy consumption by air conditioning and the outdoor air temperature since the amount of energy consumed by air conditioning is much higher than the others.

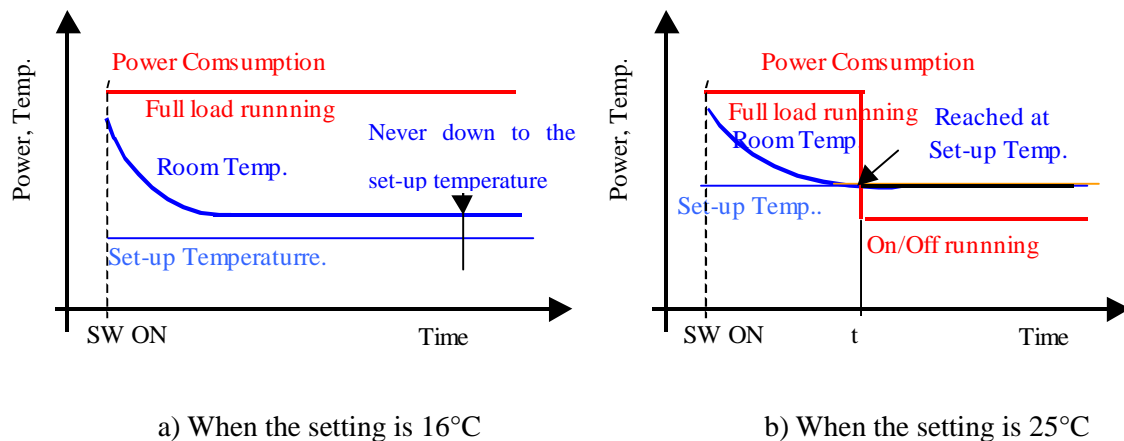
Figure 2.4 - 1 Operating Status of Air Conditioners Depending on Temperature Settings

However, 16°C is too low and the room temperature does not usually stay at 16°C. The following graphs show the operating status of air conditioners depending on the temperature settings:

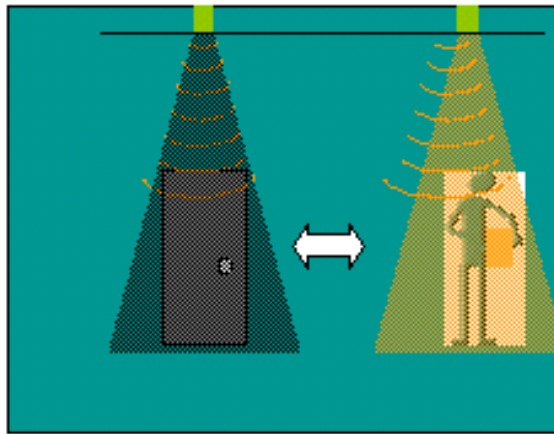
Figure 2.4 - 2 Lighting Control Using a Human Body Sensor

The purpose of lighting is to illuminate the areas where people work and to ease the working except for special cases such as crime prevention. Therefore, energy conservation is achieved by turning off or dimming lights when there are no people. Human body sensors automatically perform this function. The figure shows how a human body sensor works.

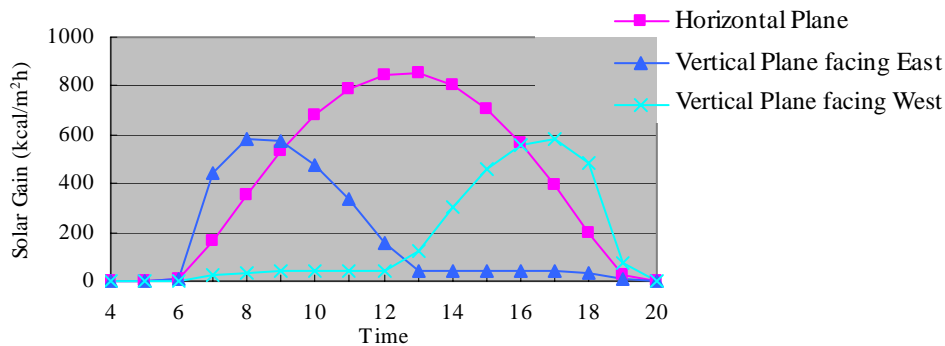
Figure 2.4 - 3 Solar heat gain Status in Summer (in Naha City)

The following graph shows the design solar gain in summer in Naha city which is located at the lowest latitude in Japan (close to the latitude of Vientiane) (referring to "Calculation method for the Maximum Design Heat Load" by The Society of Heating, Air-Conditioning and Hygienic Engineers of Japan).

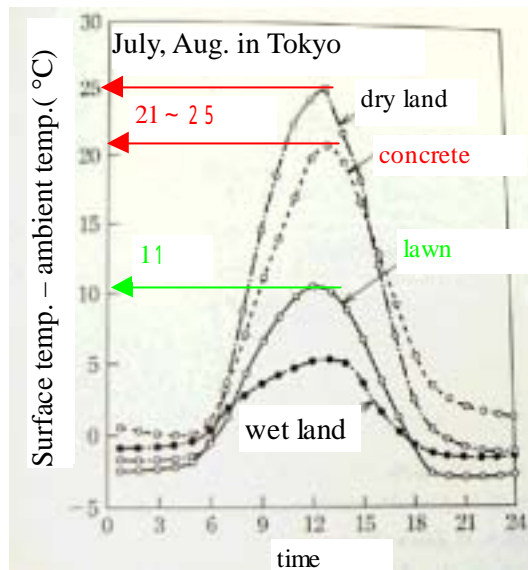
Figure 2.4 - 4 Temperature Rise on the Ground Surface Caused by Solar heat radiation

The following graph shows the changes of the temperature rise caused by solar heat gain depending on the status of the ground.

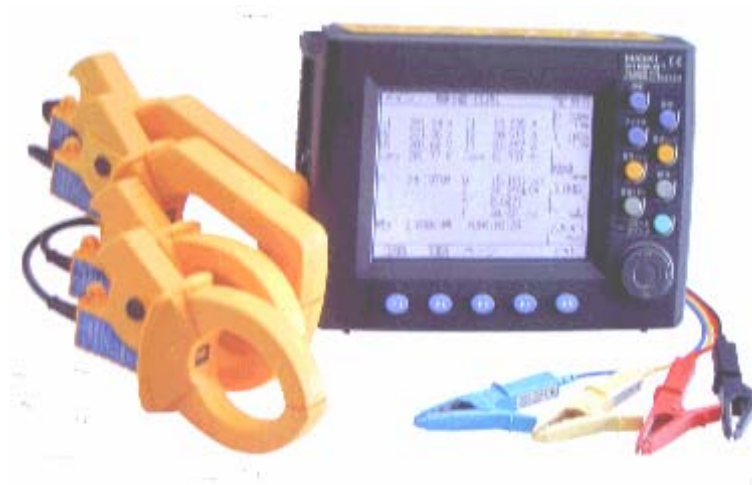
Figure 2.5 - 1 Watt-hour meter with a Recording Feature

The suitable watt-hour meters are available from measurement manufacturers and the devices allow you to enter data directly into a personal computer and analyze the data. The watt-hour meters are equipped with features to make different kinds of measurements such as higher harmonics and distortion rates. The following figure shows the watt-hour meter manufactured by H company

and it costs about 400,000 yen.

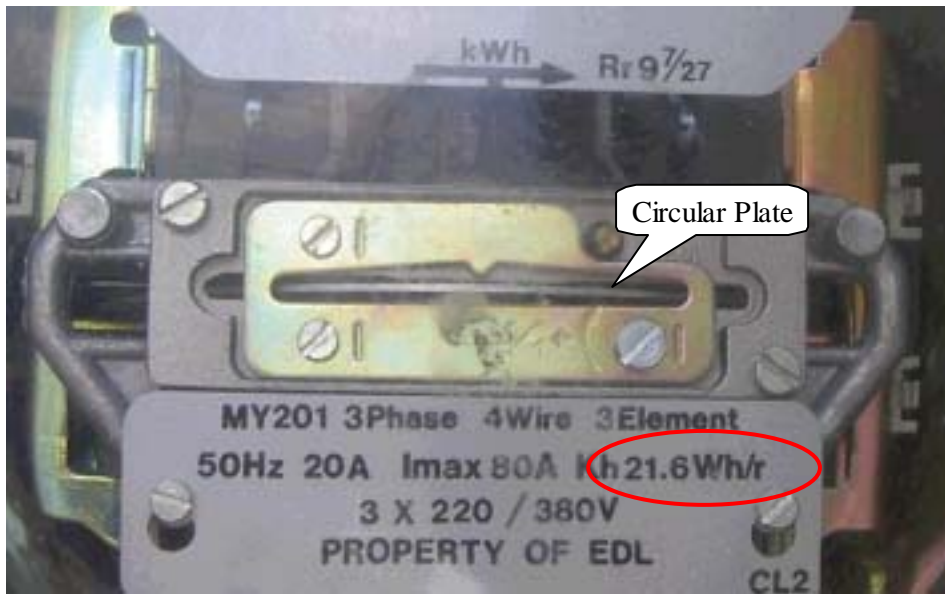
Figure 2.A - 1 Watt-Hour Meter for Supplied Electric Power

The photograph shows a watt-hour meter for supplied electric power for measuring the electric power for pools.

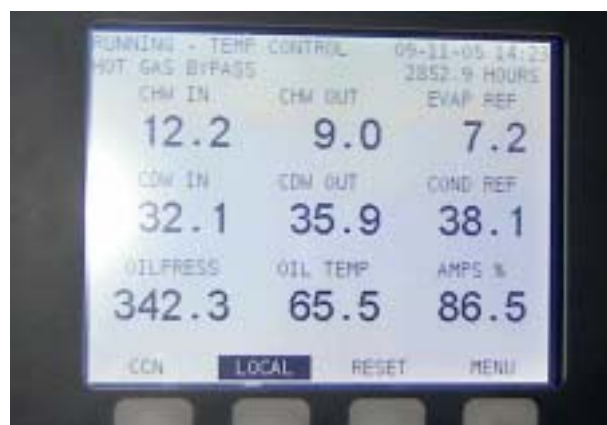
Photograph 3.5 - 1 Chiller Panel Display

The following photograph shows the panel display indicating the operation status of a turbo chiller.

The panel display indicates that the inlet temperature of chilled water is 12.2°C and the outlet temperature is 9.0°C. The outlet temperature is set rather high to

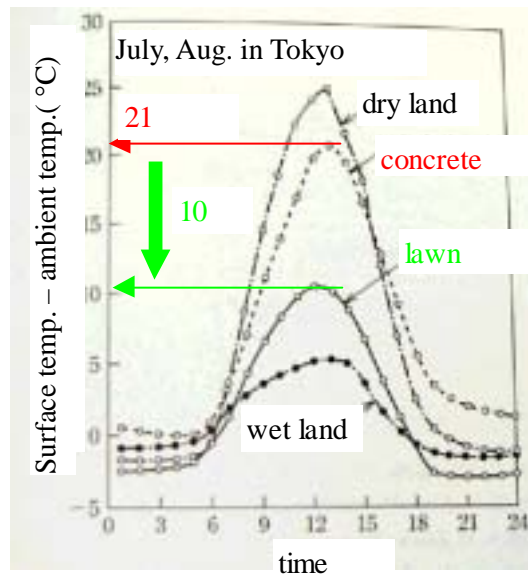
Figure 3.5 - 5 Effects of Lawn and Ponds

The following graph shows the rise of the temperature caused by solar radiation depending on the condition of the ground.

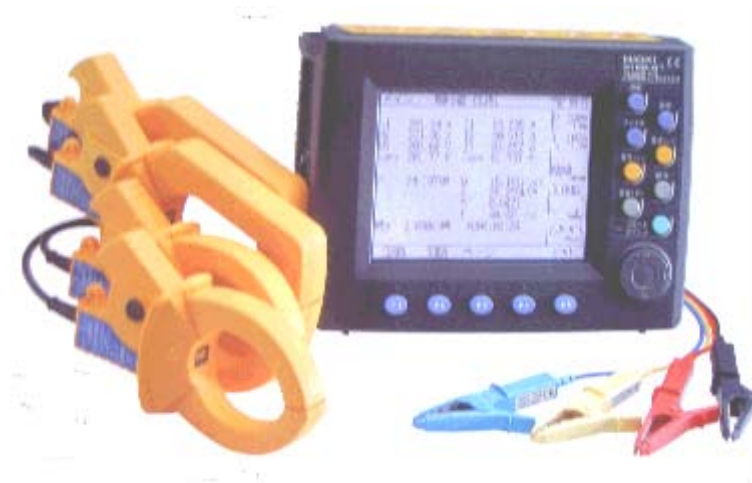
Figure 3.5 - 9 Watt-hour meter with a Recording Feature

Commercial watt-hour meters are available from measurement manufacturers and the devices allow you to enter data directly into a personal computer and analyze the data. Watt-hour meters are equipped with features to make different kinds of measurements such as higher harmonics and distortion rates. The following figure shows a watt-hour meter manufactured by H company and it costs about 400,000 yen.

To detect devices with problems and pursue further energy conservation, an energy manager requires measurement devices for investigations. We recommend a watt-hour meter with a recording feature.

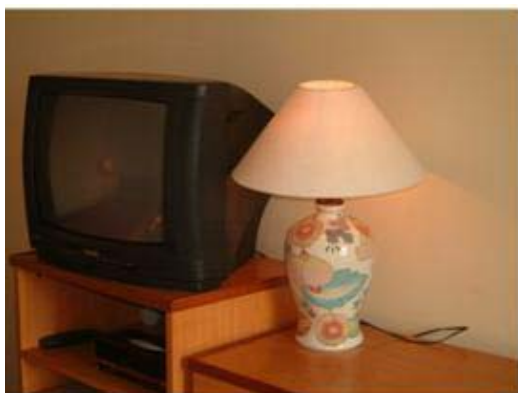
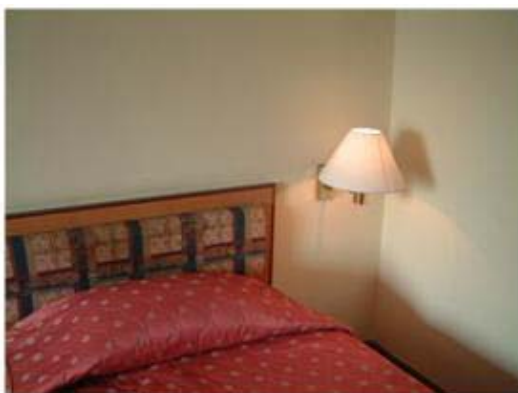
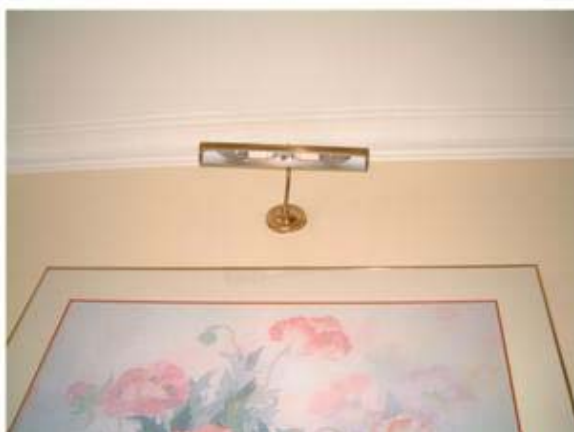
Incandescent lamps were used in guest rooms as shown in the photographs. By replacing those incandescent lamps with high-efficiency lamps, electric power can be reduced.

The following table shows the amount of expected effects of the improvement.
By replacing 40-W incandescent lamps with 7-W fluorescent lamps, 24,528kWh electric energy consumption can be reduced annually.

Incandescent lamp	40W	5Num	200W	0.8	160W
High Efficiency Lamp	7W	5Num	35W	0.8	28W
Difference					132W
Energy Saving/room	132W				
	101Room				
	13.3kW				
Occupancy rate	0.63				
	8.4kW				
	8h				
Energy Saving/day	67.2 kWh/d				
	365d				
Energy Saving/year	24,526kWh/y

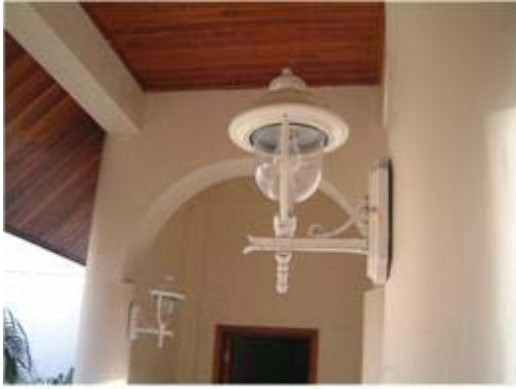
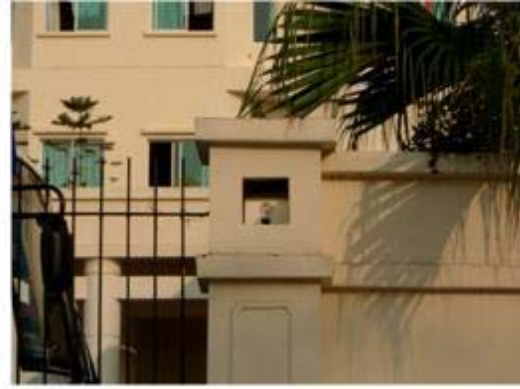
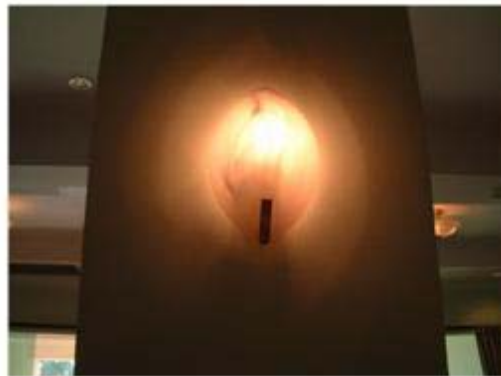
Incandescent lamps were also used in corridors, external walls, and restaurants.
By replacing those incandescent lamps with high-efficiency lamps, electric power can be reduced.

The following table shows the amount of expected effects of the improvement. This improvement can reduce 10,407 kWh annually.

Save			
Corridor	40W	8Num	7W	33W	12h		3.168kWh/d	
Wall	40	48	7	33	12		19.008kWh/d	
Restaurant	40	16	7	33	12		6.336kWh/d	
Total							28.512kWh/d	
1 Year					365	d	10,407kWh/y

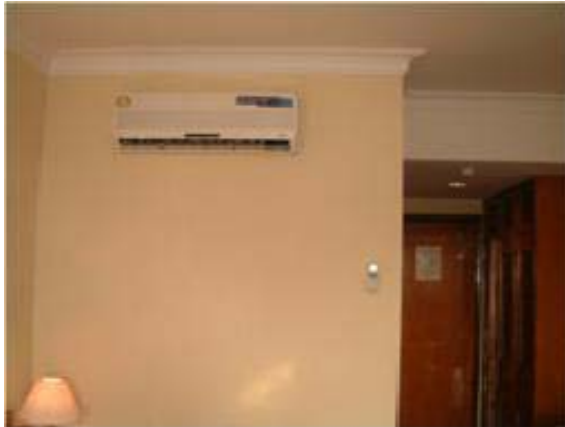
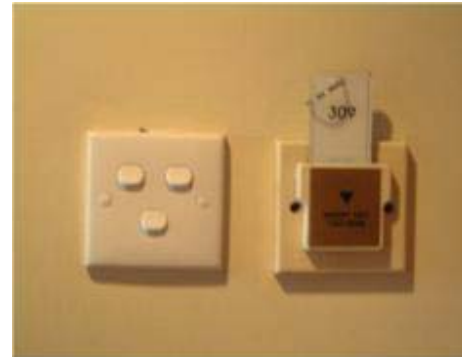
By linking air conditioners with key tags, energy is not wasted when guests

leave their rooms. When we assume air conditioners stop for two hours, the amount of electric energy that can be saved hotel-wide is 44,592 kWh as shown in the table.

AC	1920	W
Load Ratio	0.5	
1 Guest Room	960	W
	101	Rooms
	96.96	kWh
Occupancy rate	0.63	
Sub Total	61.085	kW
Saving Time	2	h
Total	122.17	kWh/d
	365	d
1 Year	44,592	kWh/y

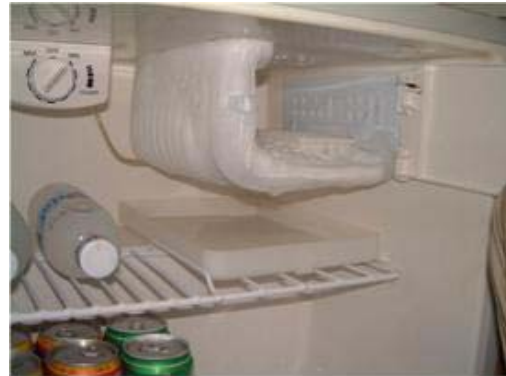
As shown in the photograph, frost was accumulated in the refrigerators in guest rooms, greatly reducing the cooling efficiency. Since refrigerators were not linked with the key tag system, they always ran in all the rooms. Although the electric energy consumed by each refrigerator is small, we can expect some effect if all the refrigerators in the hotel are improved. When we assume the rate of the effect of the improvement to be 0.2 and calculate, 826 kWh can be reduced annually by improving the maintenance of the refrigerators.

Refrigerator	70	W
Load Ratio	0.2	
	14	W
	8	h/d
	112	Wh
	101	Rooms
	11.3	kWh
Efficiency Recover	0.2	
	2.26	kWh/d
	365	d
1 Year	826	kWh/y

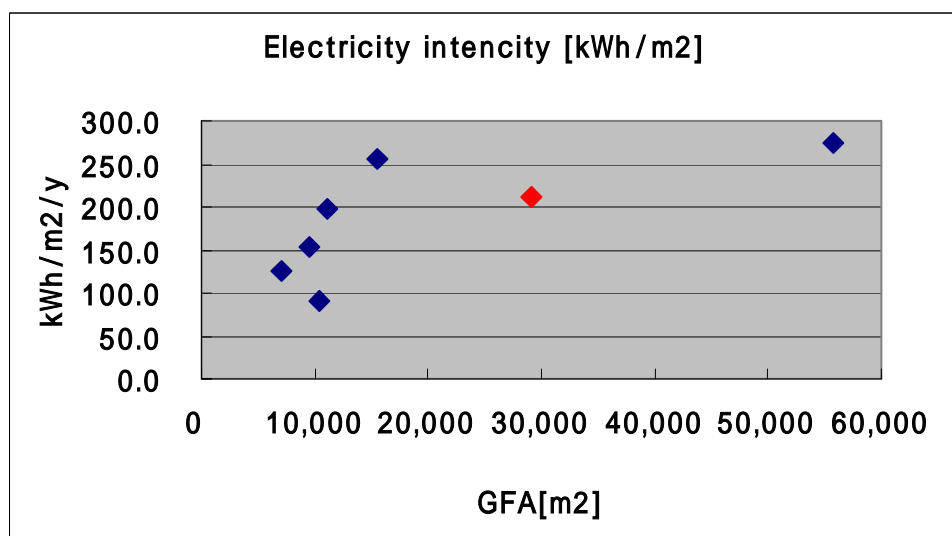
The following graph shows the annual electric energy per unit area (the annual electric energy is the vertical axis). The value of Hotel Nikko Hanoi is 211 kWh/m².

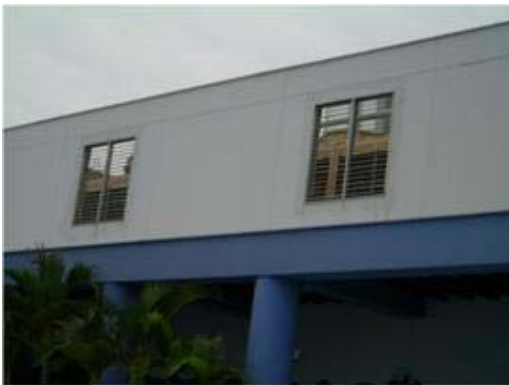
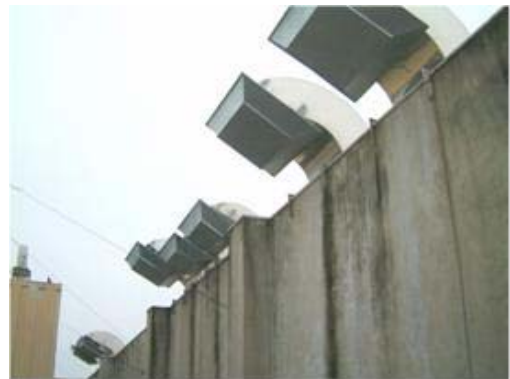
An opening was made in the external walls of the cooling towers to improve efficiency. The exhaust duct was improved since it was affecting the cooling towers badly.

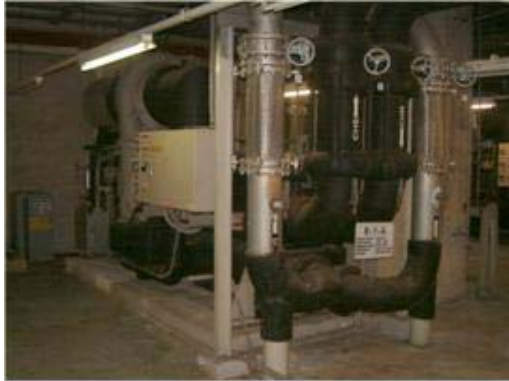
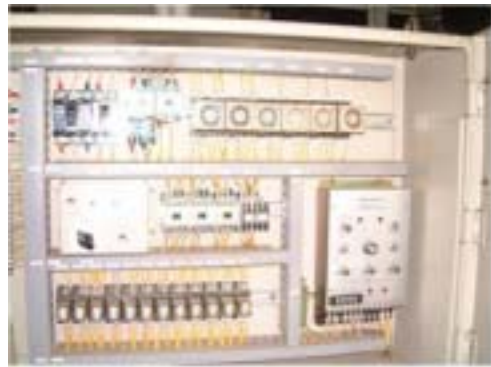
The chillers were run with the outlet temperature of chilled water being set to 7°C throughout the year.

Raise the outlet temperature of chilled water during the seasons with less cooling load to run the chillers efficiently.

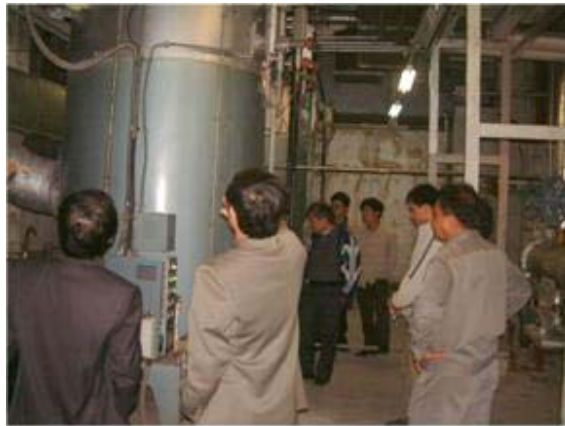
Two oil-fired boilers were run. However, the boilers were run without measuring and managing the fuel air ratio.

Measure the fuel air ratio and run the boilers at an adequate ratio.
