2005 Prize of the Chairman of ECCJ

Energy Conservation through JIT (Just-In-Time) Operation of Air-Conditioning Units

Toyota Motor Hokkaido, Inc.
Facility Group 1, Productive Maintenance Support Division

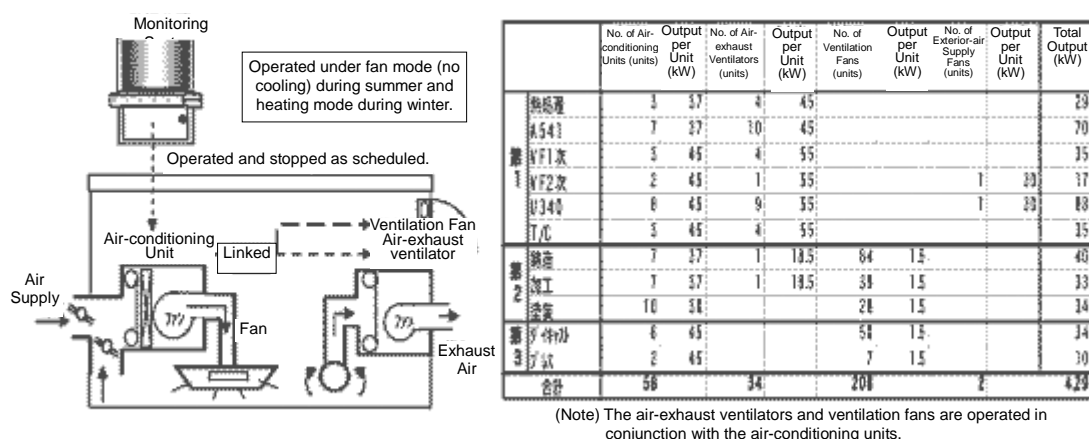
(Fig. 1) Outline of the Process Chart and List of Air-Conditioning Equipment in the Plants

Fig. 1 shows the outline of the facility of our project. Air-conditioning units in the plants of Toyota Motor Hokkaido are operated and stopped as scheduled under control of a monitoring system. The units are switched to fan mode (no cooling) during summer and heating mode in winter for environmental control of mist and room temperature in the plants.

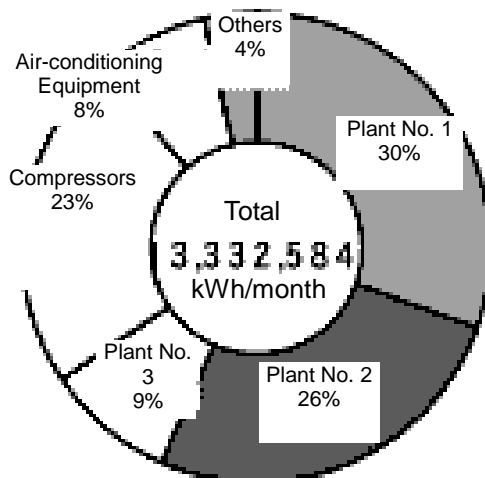
(Fig. 2) FY2003 Electric Consumptions in the Plants

After obtained ISO14001 certification in 1999, the company has been actively promoting energy conservation activities as an entire company project. Among various electric consumptions, compressors account for the largest portion except for the power used for manufacturing in the three plants. For the compressors, some activities to prevent air leakage and measures to lower air-supply pressure in order to reduce the electric consumption were already implemented. Considering the above, we determined to work on, this time, the electricity used for air-conditioning, which accounts for 8% of total consumption.

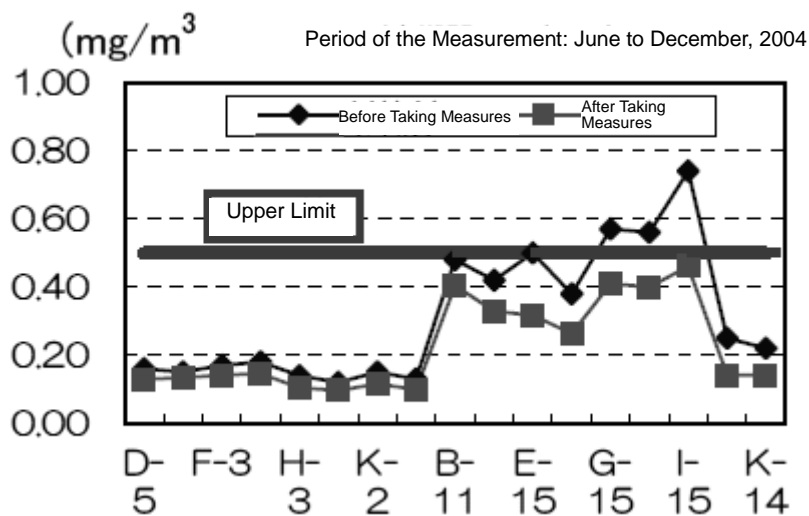
(Fig. 5) Average Mist Level before and after Taking Actions on Mist Generation Sources in the Plant No. 1

Some points to measure mist concentration level were selected from the places which had some employees usually working and had an average mist level (Fig. 5).

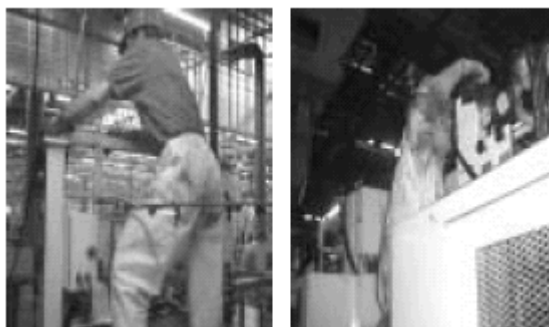
(Fig. 6) Measures on Mist Generation Sources

After taking some actions on mist generation sources, high mist level on some points detected during the measurements was improved to below the limit (Fig. 6).

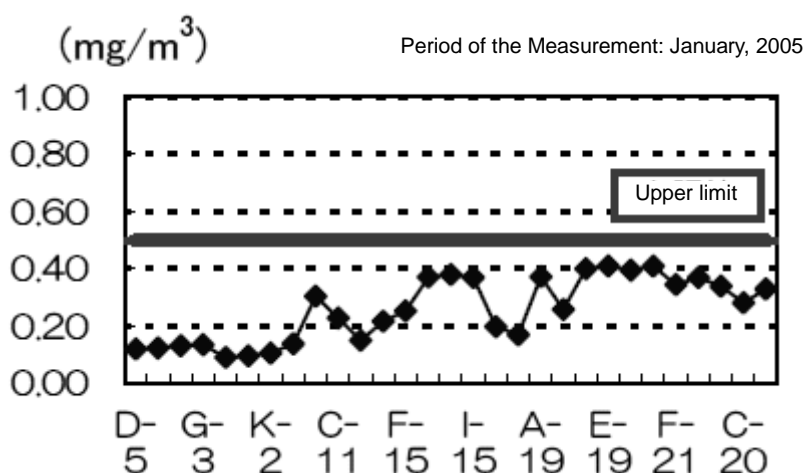
(Fig. 7) Average Mist Level after Stopping Air-conditioning Units in Plant No. 1

Next step was to see if the mist level could be kept below the limit after stopping air-conditioning units during production line stop. As a result of our research, it was verified that the mist level was fulfilling the required criteria even after stopping the air-conditioning units (Fig. 7).

Based on the findings, we revised the air-conditioning operation schedule so that the units would be immediately suspended when production lines stopped running.

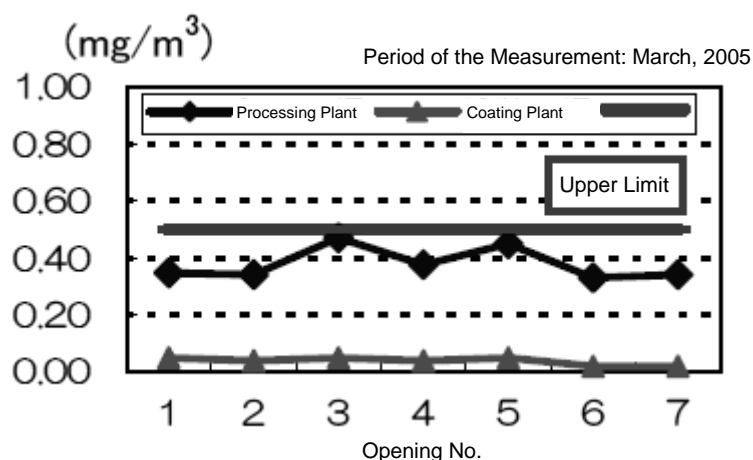
(Fig. 11) Average Mist Levels of Processing and Coating Plants

In order to prevent the mist in the processing plant from entering into the coating plant and causing quality defect, air-conditioning units were operated even while the lines were not running, so that the air in the coating plant was kept pressured (Fig. 11)

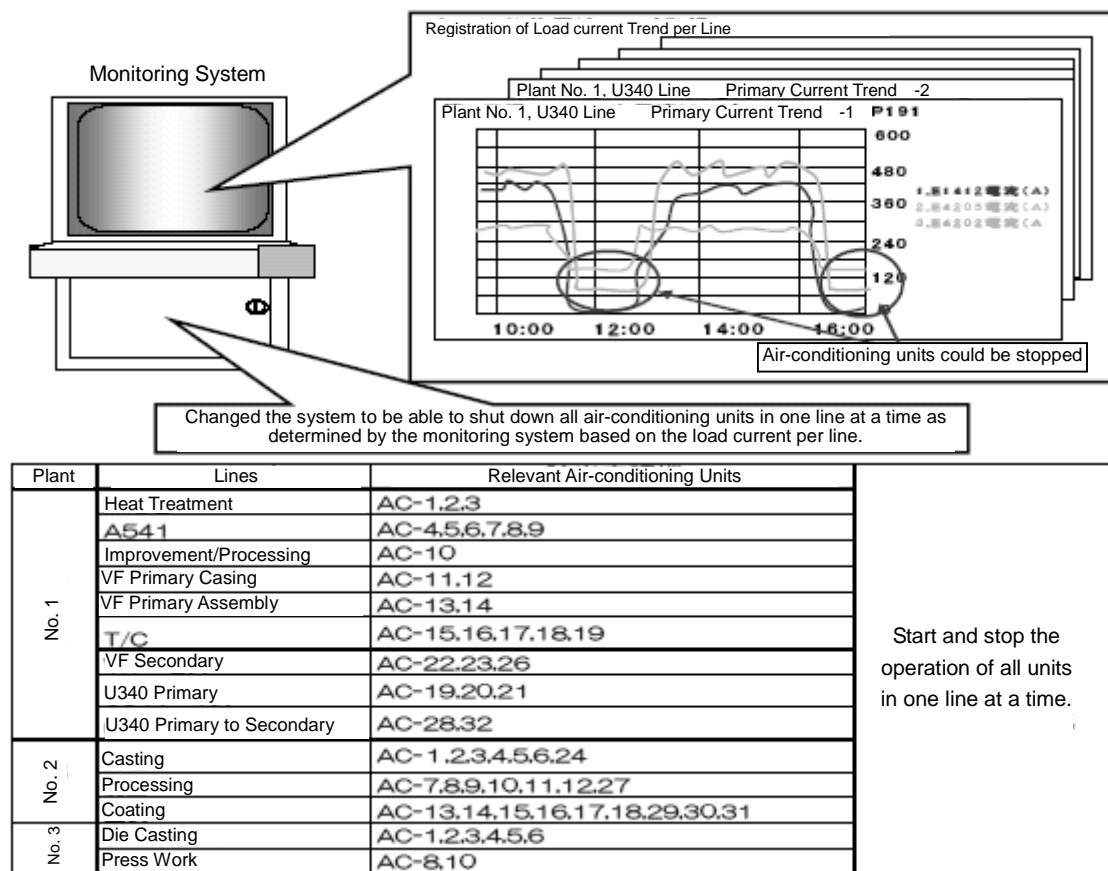
(Fig. 15) Load Current per Line Recognized by Monitoring System and Shutdown Operation of the Air-conditioning Units per Line

Based on the study results, we entered information of the current trend of each line to the monitoring system and kept monitoring the load current. Workers were required to stop the air-conditioning units upon hearing an alarm set to be sound when the electric current went below a certain level.

Judging from the monitoring for two weeks, it was confirmed that the new practice would cause no problem. We improved our rule from stopping the air-conditioning units one by one to shutting down all the units in one line at a time under the control of the monitoring system.

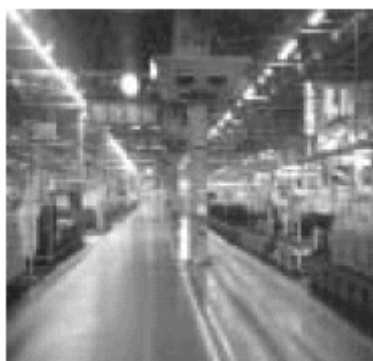
(Fig. 17) The Aisle to which AC-04 Unit was Sending Air

Since lines for heat treatment are continuously running, air-conditioning units are also continuously operated. Among those units, we found a unit sending air to an aisle where no one was working (Fig. 17).

AC-04 unit was kept in continuous operation with an assumption that it was sending air to a thermal treatment line.
