2009 Prize of Director General of Agency for Natural Resources and Energy

Local Public Hospital Challenges Energy-saving Activity

Kasugai Municipal Hospital

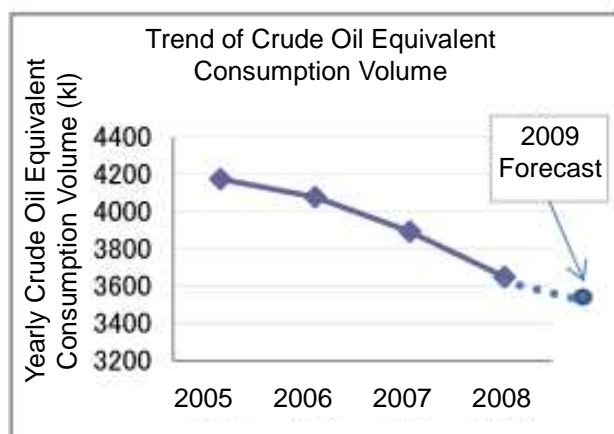
For these three years, we achieved the reduction of 526 kL of crude oil equivalent (See Fig. 4). The reduction rate is 12.6 %. Its breakdown is as follows:

Fig. 4 Trend of Crude Oil Equivalent Consumption Volume Fig. 5 Trend of Intensity

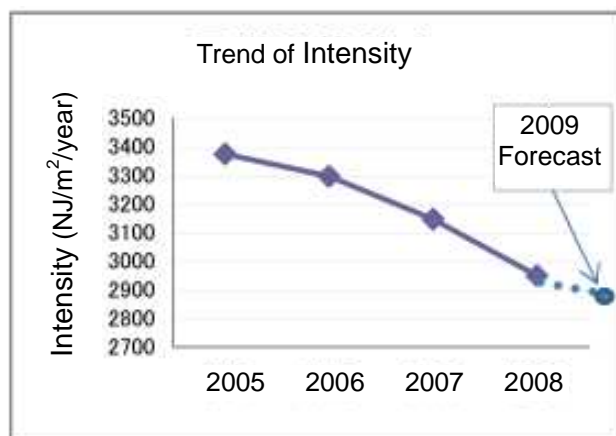
The total reduction is equivalent to 30 million yen or more. The accumulation of small efforts led to a major achievement. In terms of CO², the reduction is 938 tons. As for the intensity, we reached 2,950 MJ/m²/year, which is lower than the initial target of 3,000 MJ/m²/year (See Fig. 5). According to the pamphlet provided by the Energy Conservation Center, Japan the average value for a public hospital of this class is some 3,600 MJ/m²/year, which proves our energy-saving activity is very successful.

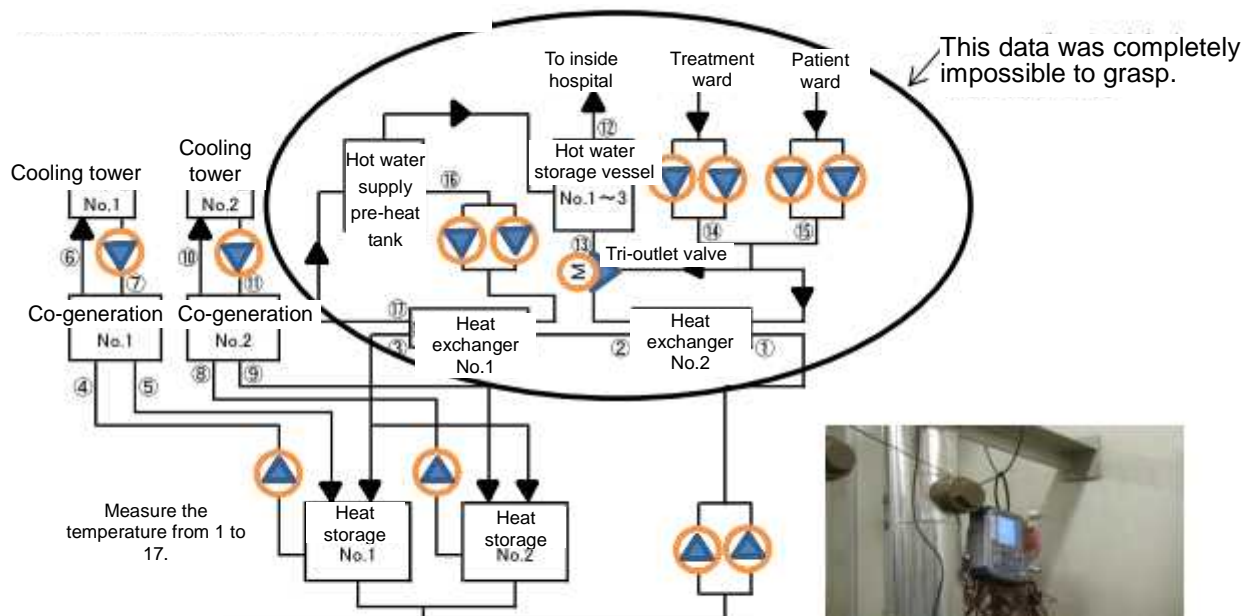
Fig. 10 Schematic chart of co-generation hot water supply piping

Next, they reviewed the co-generation operation as the case that may produce a major effect. Two units of gas-powered co-generation (output:280 kW each) are installed in this hospital. Heat is recovered in the form of steam and warm water. Since those units were installed, we have been running two of them 24 hours a day.

water that cannot be grasped by the central monitoring, they gathered and validated the data to fully visualize the heat use of co-generation. Then, it turned out that the heat use at night is problematic.

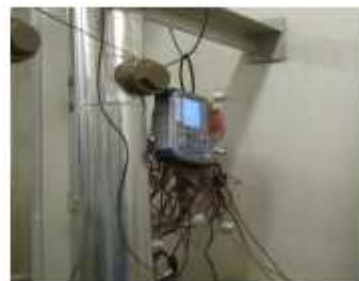
Photo-3. Thermocouple data logger

By installing a data logger to collect the accumulated data and the hidden data of warm

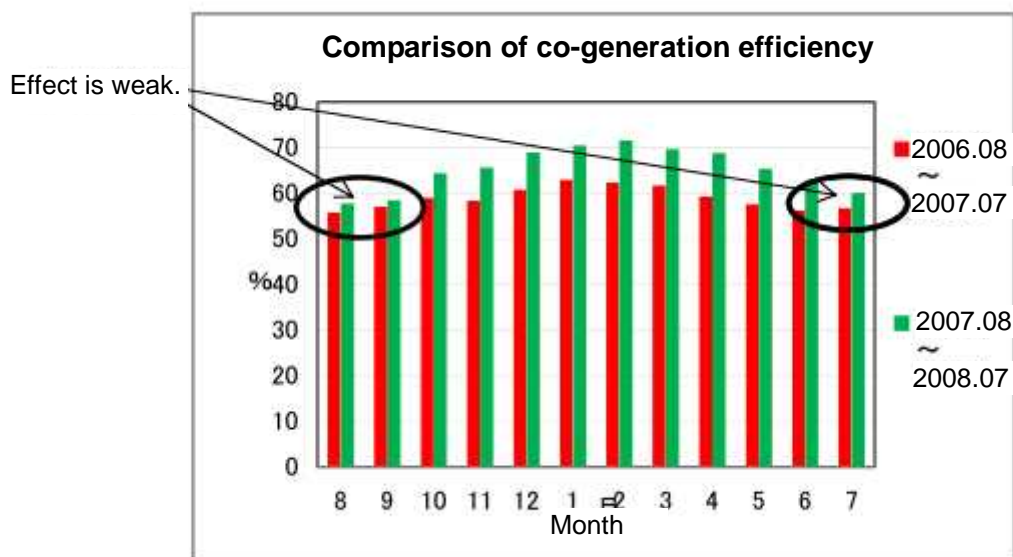
Fig. 11 Comparison of co-generation efficiency

Furthermore, when they validated the data and compared the efficiency, they found a new theme. As shown in Fig. 11, though the efficiency improves in winter, the effect is flimsy in summer.

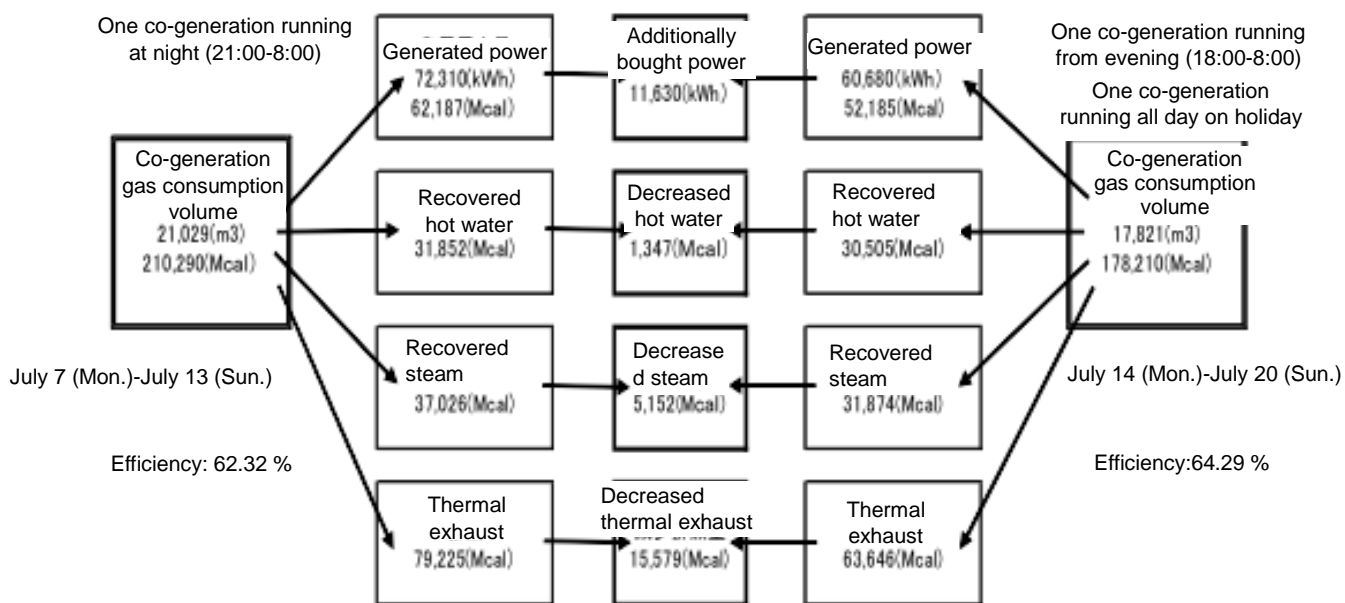
Fig. 12 Co-generation Operation Validation

As the next measure, they decided to halt one generator in the evenings in summer from August 2009. Their validation revealed a reduction of 9.6 kL was achieved in summer alone. Efficiency increased further by 2% (See Fig. 12).

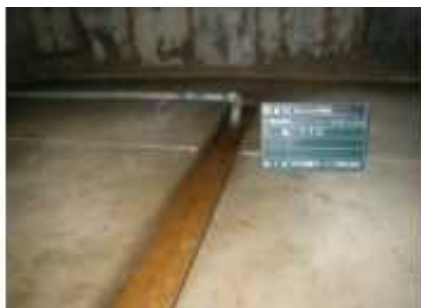
Photo-7 Before drain piping repair

Ten years have passed since this hospital was built, and water exhaust from the building is over to some extent. Therefore, we decided to completely halt the operation of four units of the trench system wind exhaust machines in the basement during the middle term and winter. As a result, we managed to reduce 3.98 kL of motor power and also achieved a load reduction of 17.7 kL in air conditioning by preventing under-floor cooling in winter and reducing radiation loss from the inside pits. In summer, since the air conditioning drain is discharged into the ditch of the basement trench, we were unable to halt the exhaust fans. To resolve this, construction of extending the drain piping was done. The piping extension to

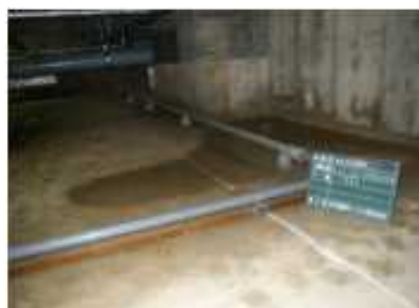
Photo-8 After drain piping repair

the water exhaust mass has made air exhaust unnecessary, enabling us to halt the exhaust fans in summer. Currently, due to the night purge in summer, fans are in operation only for three hours in the morning.

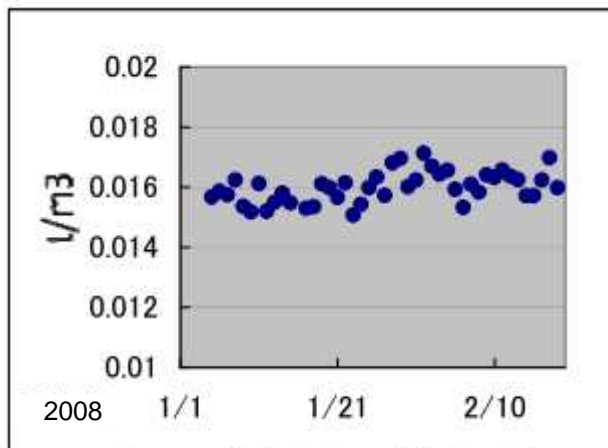
Fig. 14 Fuel cost of steam boiler (t/m³)

As a result of the thermal insulation construction, energy conservation of at least 67.77 kL has been accomplished. In particular, the efficiency of the steam boiler has increased around 5% compared with the pre-insulation conditions. As a supplementary explanation to Fig. 14, the construction lasted from January 4 until February 12, 2008. As a result, the steam volume per cubic meter of city gas was slightly rising as the construction neared the end.

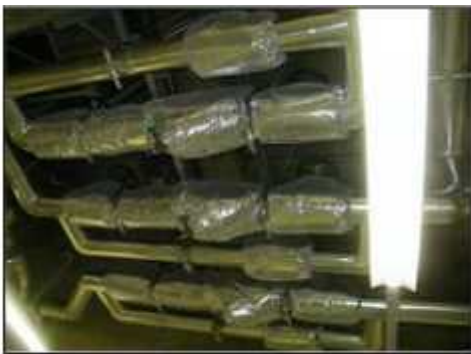
Photo-13 After thermal insulation of steam valve

To further visualize the thermal insulation effect, the pre- and post-heat retention conditions were confirmed by a thermo camera.

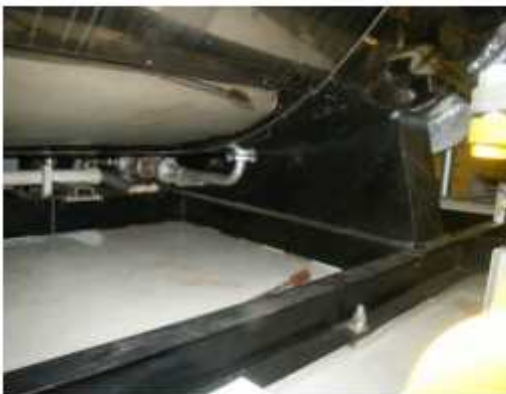
Photo-15 Before thermal insulation of boiler legs

In September 2009, the heat retention was extended to legs of steam boiler (See Photo 15,16).

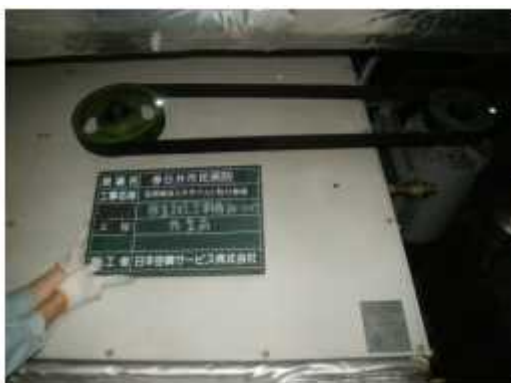
Photo-17 V-shape belt air-conditioner

As an advanced measure, there is an introduction of energy-saving flat belt. Its targets are machines like air conditioner that are driven by a V-shape belt. This time, they challenged the attachment of an energy-saving flat belt by customizing the installed air conditioner. They thought the power conveyance efficiency would be improved by changing from the V-shape belt to the energy-saving flat belt, leading to energy conservation.

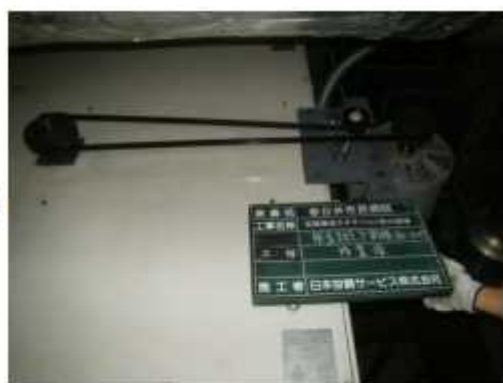
Photo-18 Air-conditioner fitted with flat belt

Photo 18 shows the air conditioner fitted with flat belt. To attach a flat belt, it is necessary to install a conveyance device called tensioner between pulleys. Tensioner is a device to control a flat belt in a zigzag. With assistance from Bando Chemical Industry Ltd., which is a maker of belts, and Nippon Kucho Service, which is a hospital facility maintenance management vendor, they somehow managed to attach the belt. After the attachment of the belt, they confirmed fans and a motor retain the same rpm (revolutions per minute) as before the attachment, and they were successful in reducing the driving current by 6% as initially planned. After 2009 as well, we plan to introduce the belt.
